Survey and Evaluation of Fine Bubble Dome Diffuser Aeration Equipment

EPA-600/2-81-222
September 1981

Daniel H. Houck
Association of Metropolitan Sewerage Agencies
Washington, D.C. 20036

Arthur G. Boon
British Water Research Centre
Stevenage, England SG1 1TH

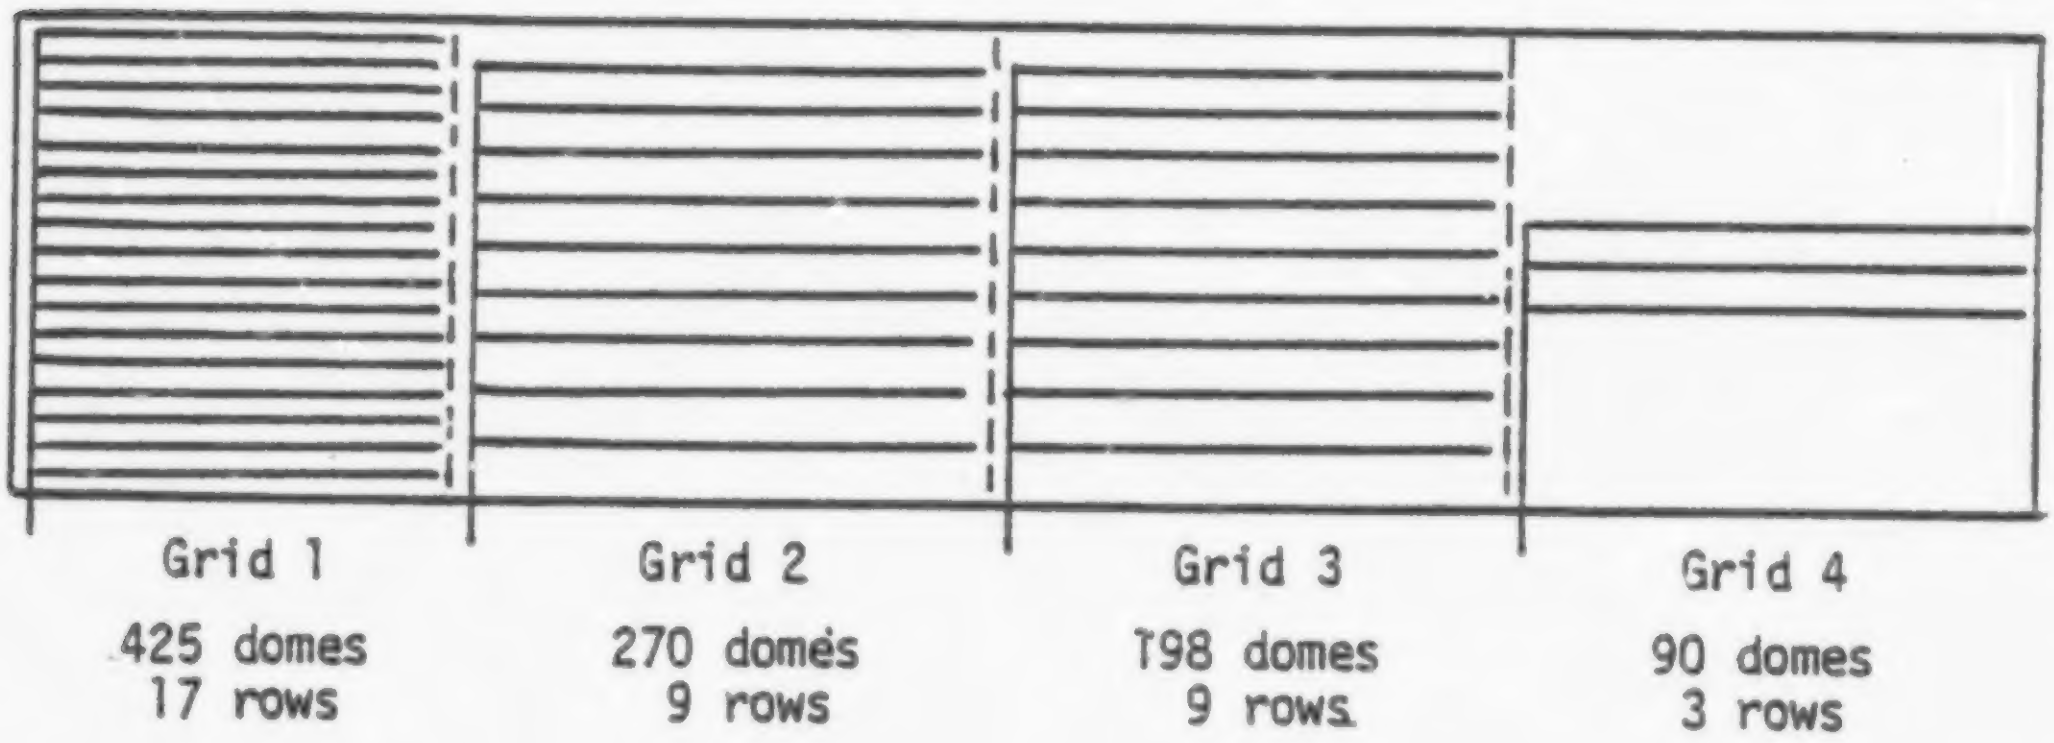
Figure 25. Tapered aeration at Oxford.

The term "tapered aeration" is used to describe systems which have progressively fewer diffusers as the tank is traversed from the inlet to the outlet end. Figure 25 shows a schematic of a plug flow tank at Oxford with tapered aeration. The diffuser distribution shown in Figure 25 is quite typical for this design approach. The diffusers in the last quarter section are concentrated in the center of the tank, causing a double spiral roll mixing effect in this zone of the tank.

As noted in Section 6, all of the surveyed plants had varying degrees of excess aeration in multi-pass systems and slime growth on domes in zones where primary effluent was introduced. These problems were largely caused by aeration basin geometry that is poorly suited to the optimum operating characteristics of dome diffusers. Discussed below is each major characteristic and how it is impacted by current basin design practices.

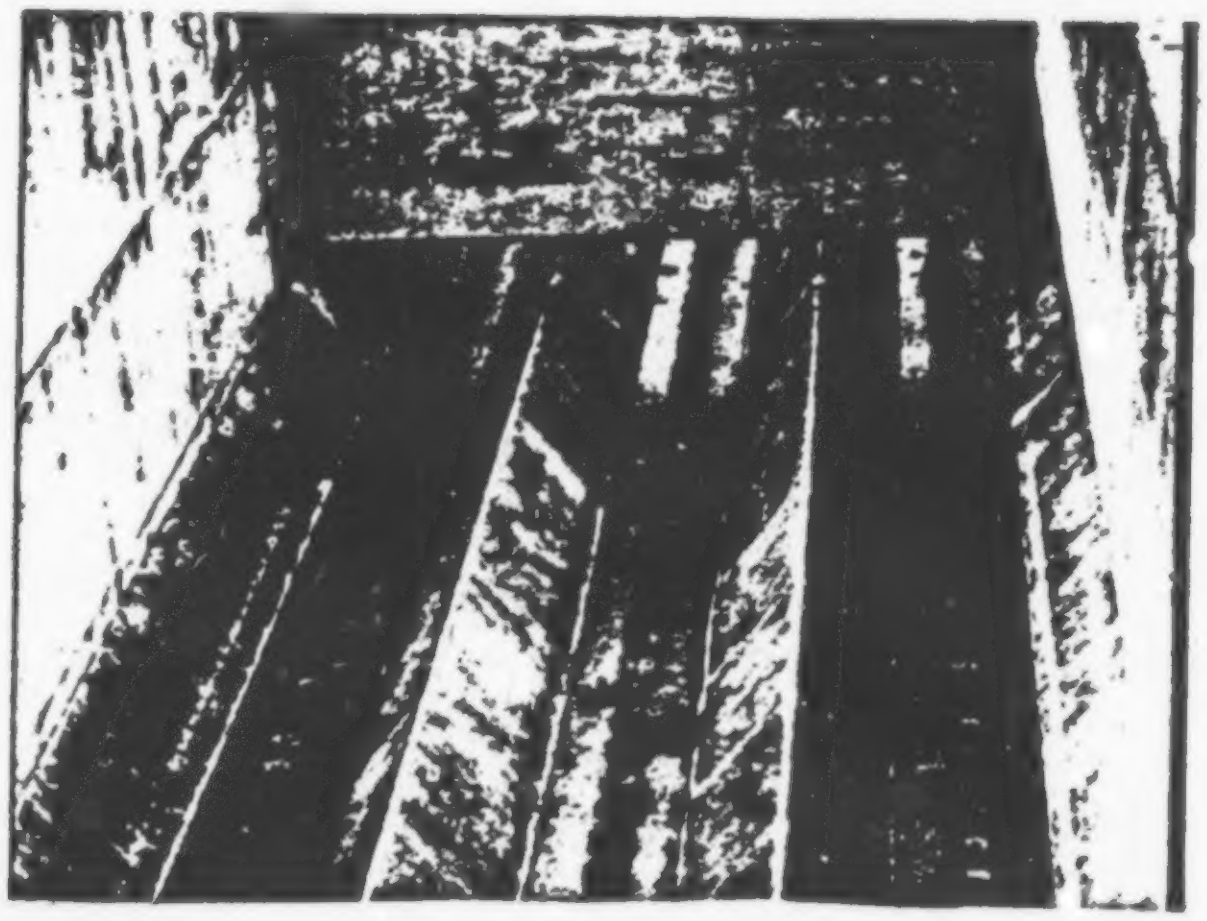
Figure 27. Ridge and Furrow tank at Ryemeads.

Depending on the age of the plant, some aeration basins were constructed with ridge and furrow floor designs. This configuration, shown in Figure 27, was originally developed as an aid in mixing and tank circulation. It has since been determined in the United Kingdom that it is costly to construct and adds little to performance; consequently, it was not seen in the newer plants included in the survey.
